# Manhole Inspection Summary

Manhole # S13AA\_025MH

Insp Date: **2/23/08 11:29 AM**

**Location** Address: **2900 LAFAYETTE AVE**

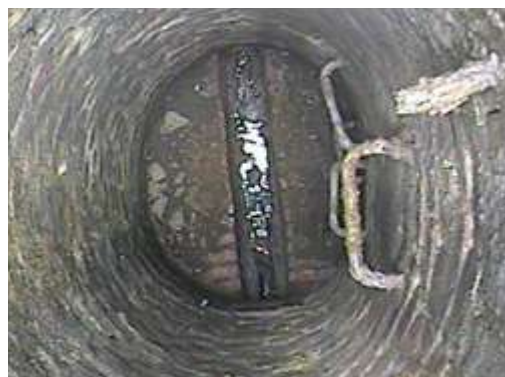
Defect 1

**Steps** Count: **6** Missing: **2** ☒ **Corroded**

CORRODED STEPS

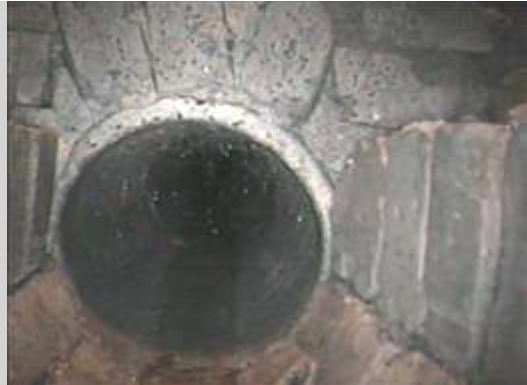
12 O'Clock Outflow

8 in. Circular Gravity Sewer  
Pipe Out @ 12 O'Clock

Pipe Material: **Clay** ☐ Pipe Lined

Invert Depth: **11.30** (ft.) Flow Characteristics: **Slow**

Infiltration: **None** Pipe Seal Cond: **Sound**

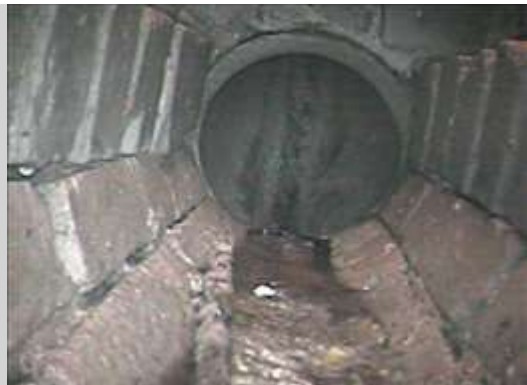
6 O'Clock Inflow

8 in. Circular Gravity Sewer  
Pipe In @ 6 O'Clock

Pipe Material: **Clay** ☐ Pipe Lined

Invert Depth: **11.07** (ft.) Flow Characteristics: **Slow**

Infiltration: **None** Pipe Seal Cond: **Sound**
